Survey No.: CH-78 (~~PACS B14~~) Construction Date: 1761, circa 1840
Name: Pleasant Hill
Location: 9205 Marshall Corner Road, Pomfret vicinity, Charles County

Name: Pleasant Hill

Maryland Historical Trust
Maryland Inventory of Historic Properties Form
U.S. 301 South Corridor Transportation Study

Survey No.: CH-78 (PAGE B14)

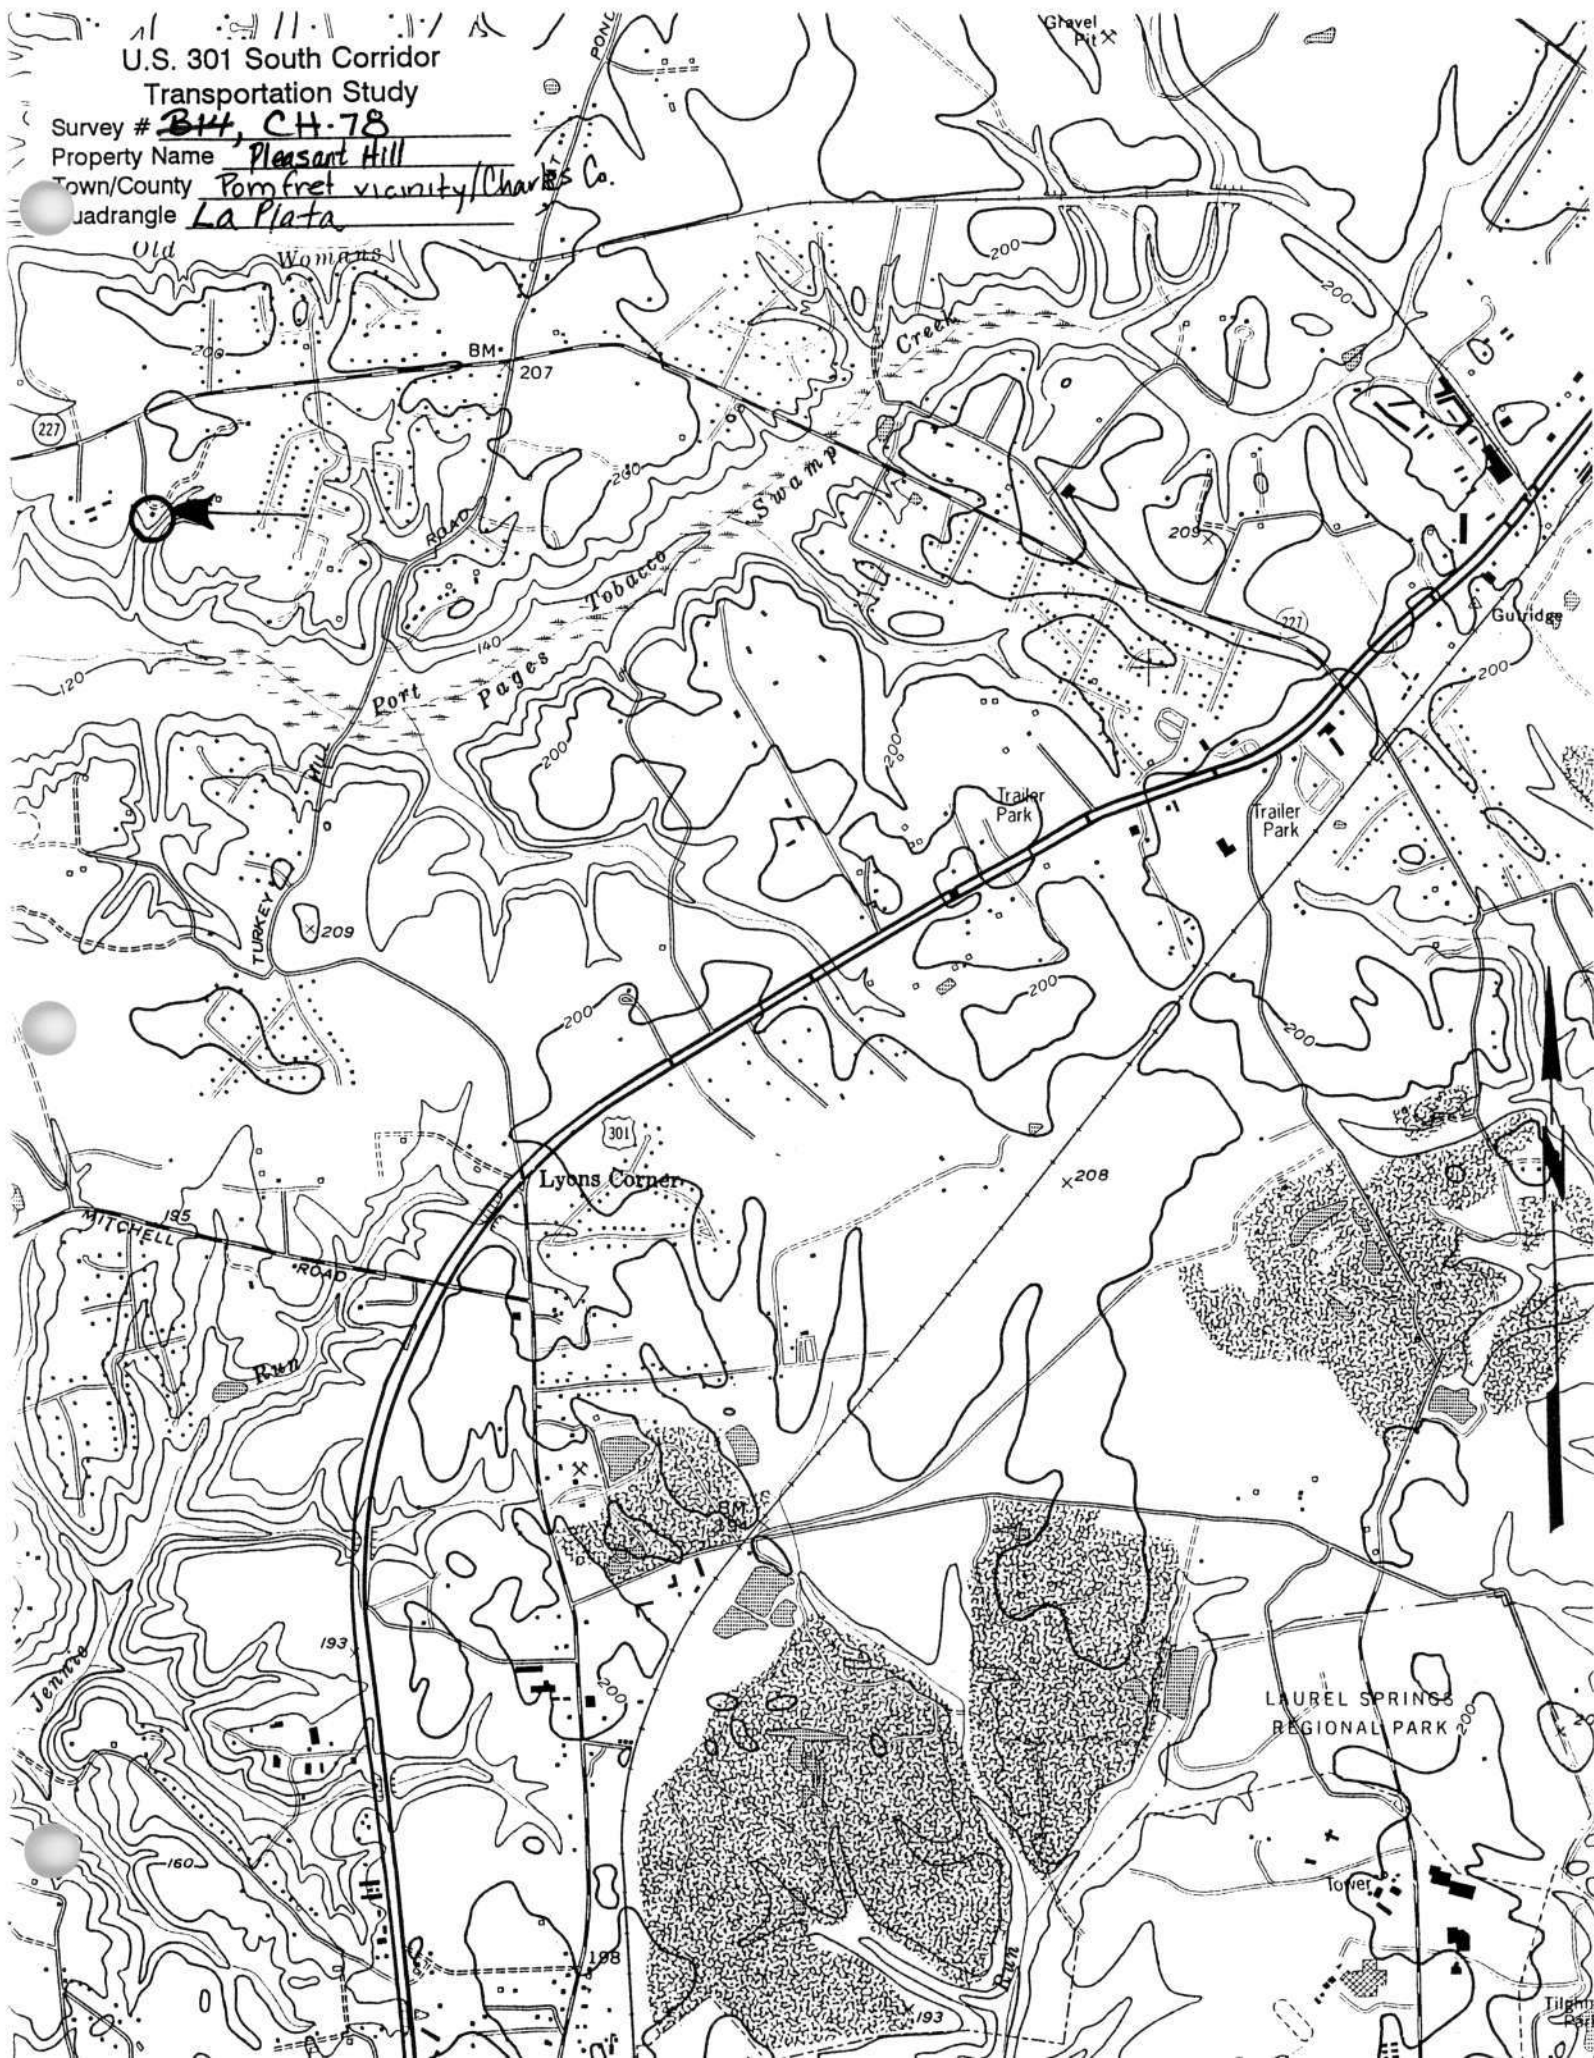
1. CH-78
2. Pleasant Hill Charles County, MD
3. Ryan McKay, 9/96
4. P.A.C. Spero + Co 410 W Chesapeake Ave.
#412 Baltimore MD 21204
5. 9205 Marshall Corner Road
North elevation of house South view
6. 1 of 16

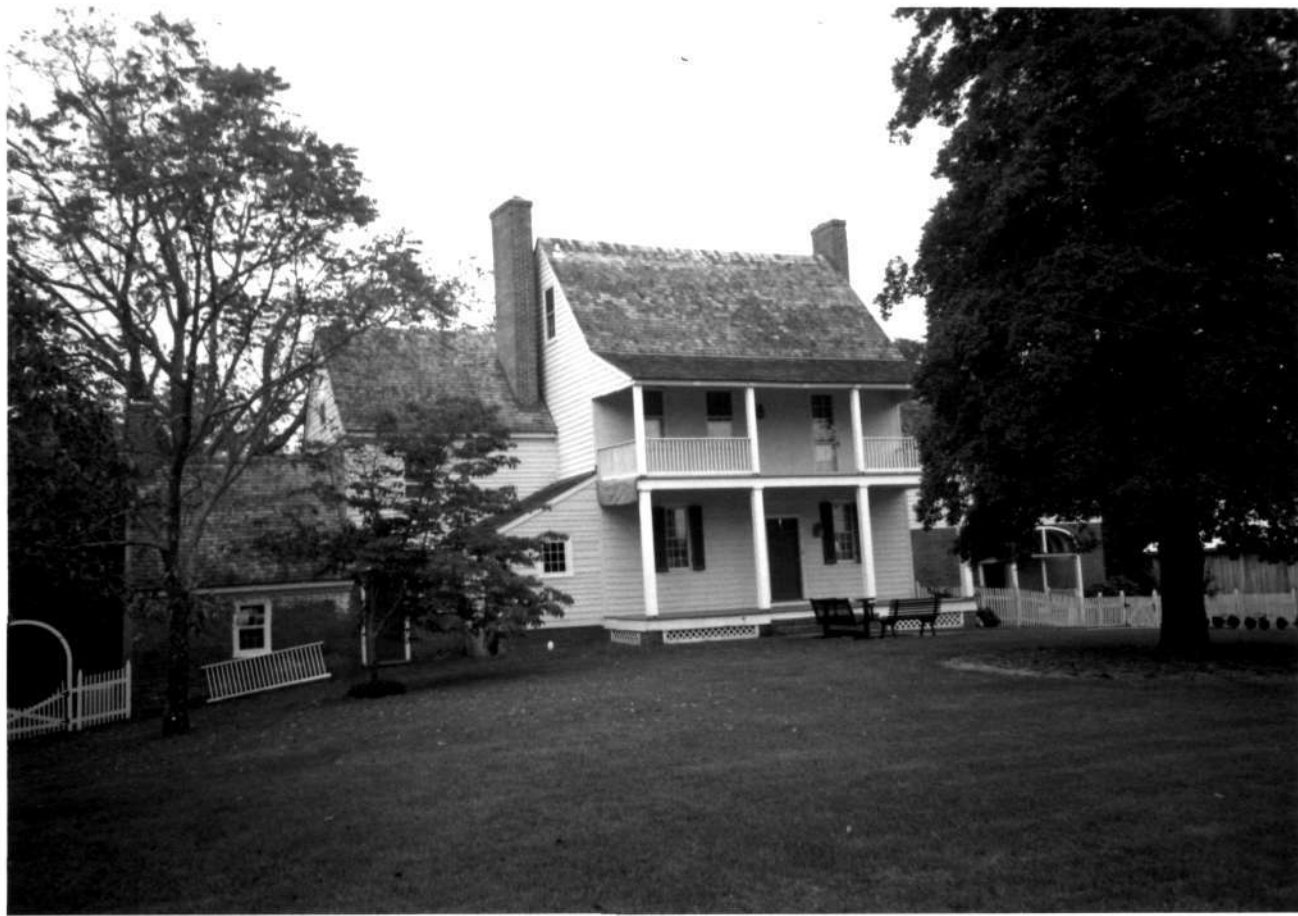
6 2 of 16

5 9205 Marshall Corner Road North
elevation of Main house Southwest view

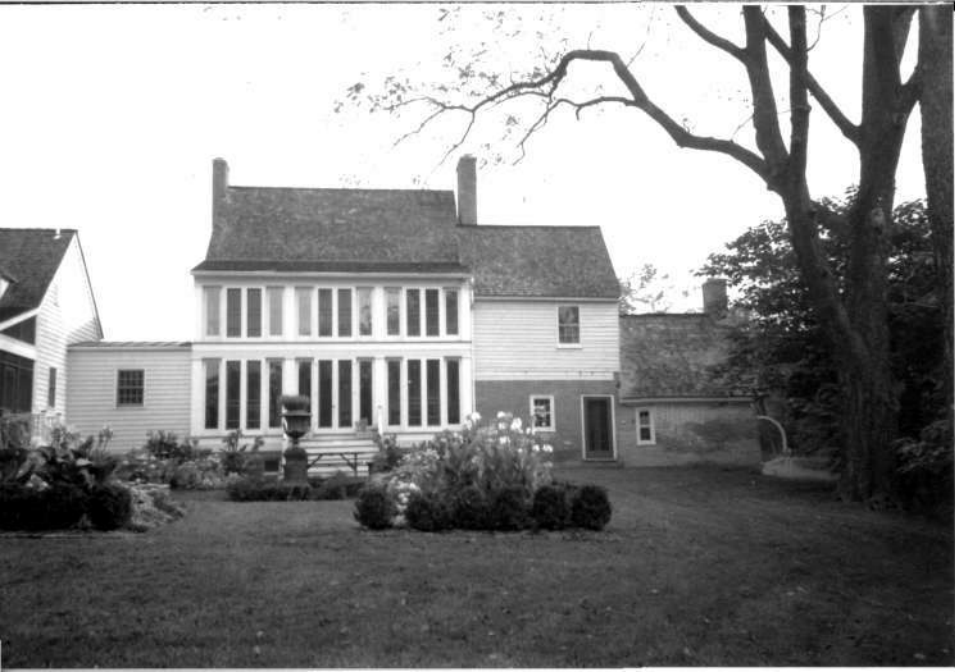
1. CH-78
2. Pleasant Hill Charles County, MD
3. Ryan McKay. 1/96
4. P.A.C. Space & Company, 410 W
Chesapeake Ave #412 Baltimore, MD 21204
5. 9205 Marshall Corner Road
Partial South elevation of House
North View
6. 4 of 16

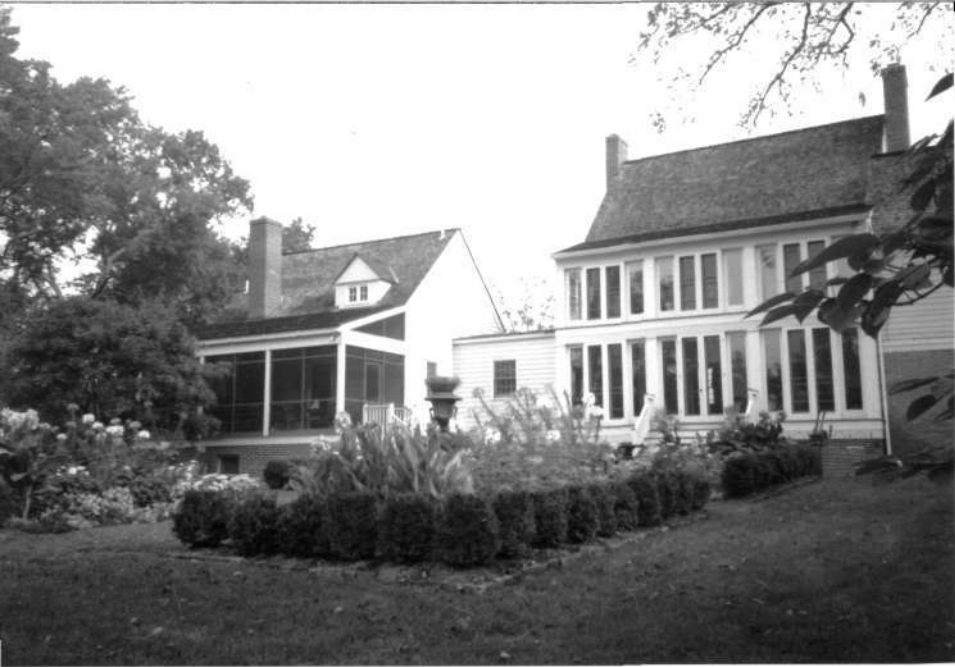
6. S of 16

5. 9205 Marshall Corner Rd
partial south elevation North west view

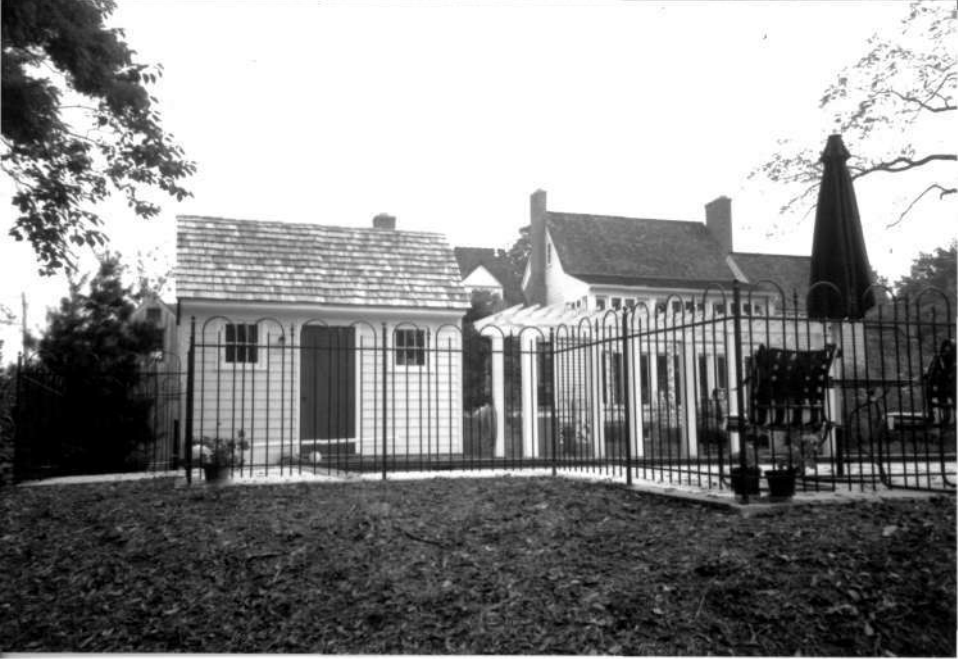
1. CH-78
2. Pleasant Hill, Charles County, MD
3. Repr. McKay 1 to 10
4. P.A. C. Spent Co 40 W. Chesapeake Ave #412, Baltimore MD 21204
5. 9205 Marshall Corner Road
partial South elevation of House with
pool house North view

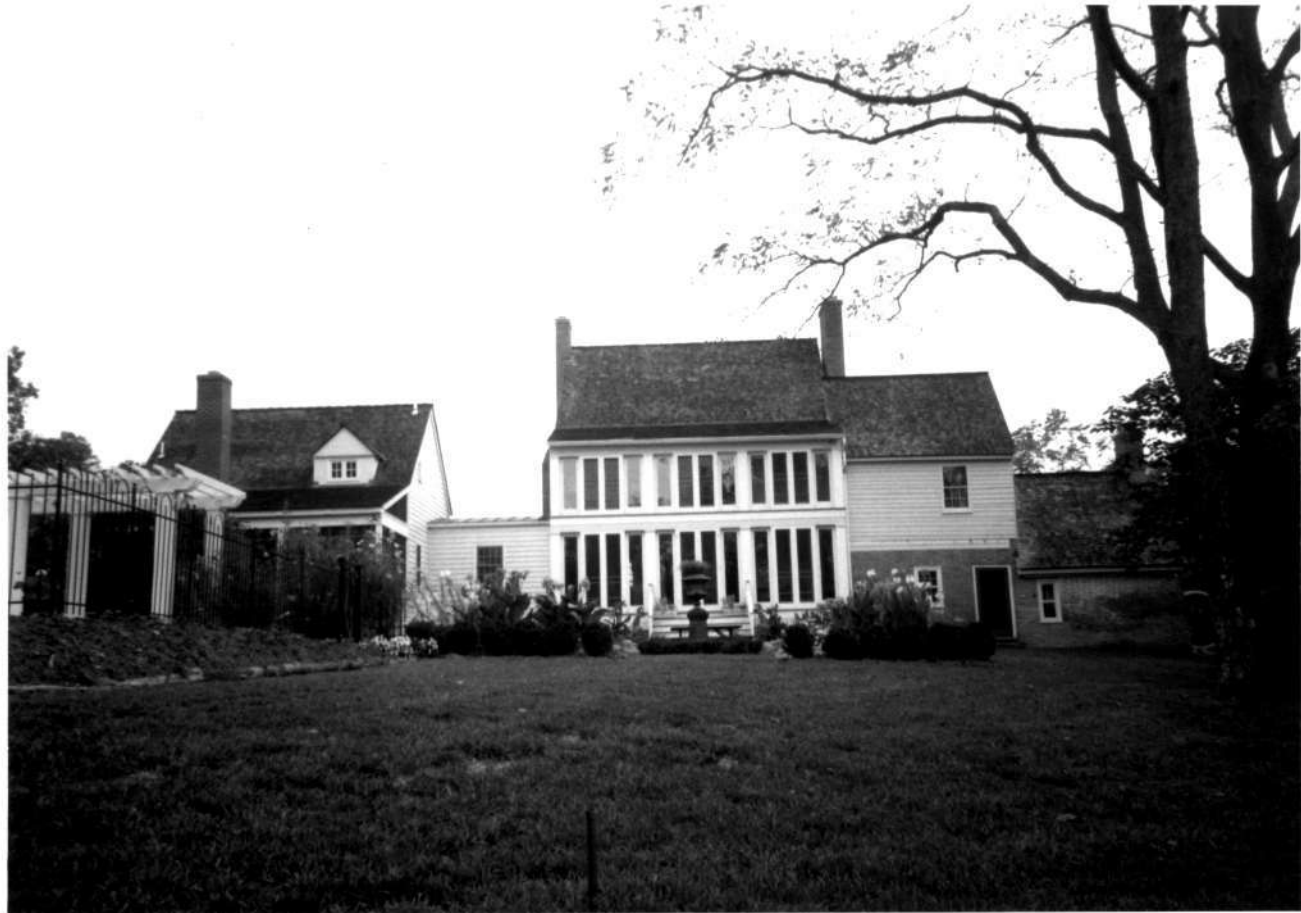
6 7 of 16

5 9205 Marshall Corner Road
South elevation of Main house, North
View

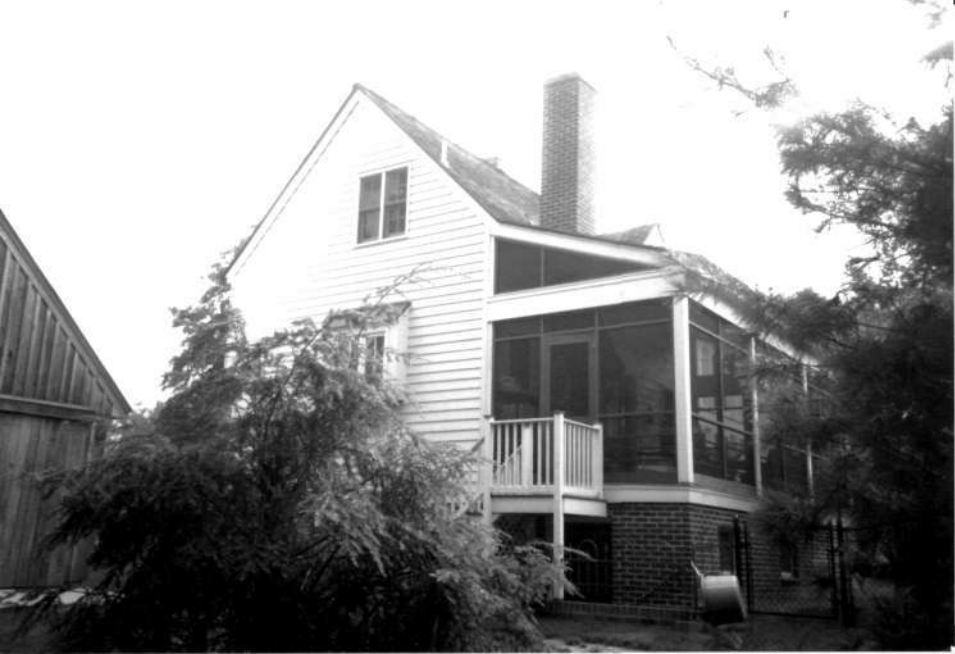
1. CH-28
2. PLEASANT - N 1, Charles County, MD
3. Ryan McLean Ave
4. P.A.C. Sperry H. R. (Kempstead)
Ave., 412 - J. W. S. A. MD 21767
5. 9205 Marshall Corner Road
Partial West elevation Northeast view
6. 8 of 16

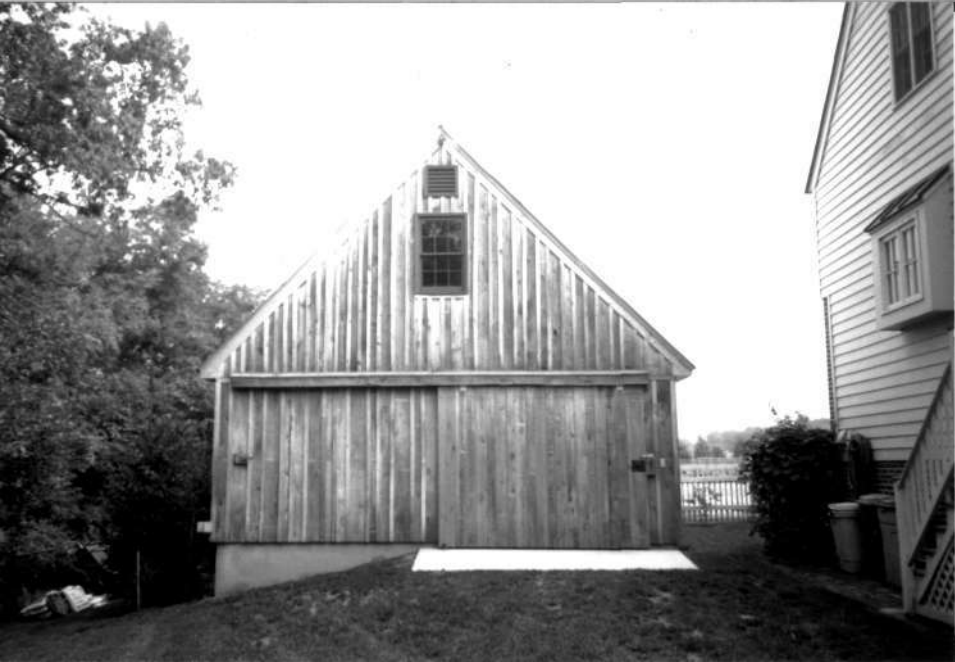
6. 9 of 16

5. 9205 Marshall Corner Road
garage North view South elevation

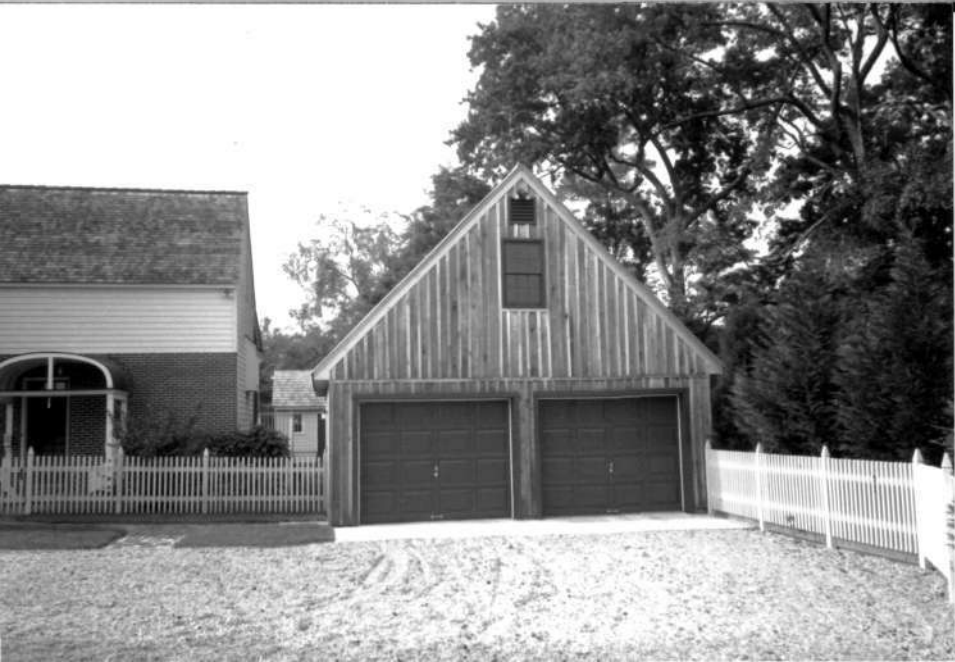
1. CH-78
2. Pleasure Hill Charles County, MD
3. Ryan Road
4. P.A.C. Sperry & Company, 40. W. Chesapeake Ave., Ste 412, Baltimore
5. 9205 Marshall Corner Road
North elevation of Garage South
View
6. 10 of 16

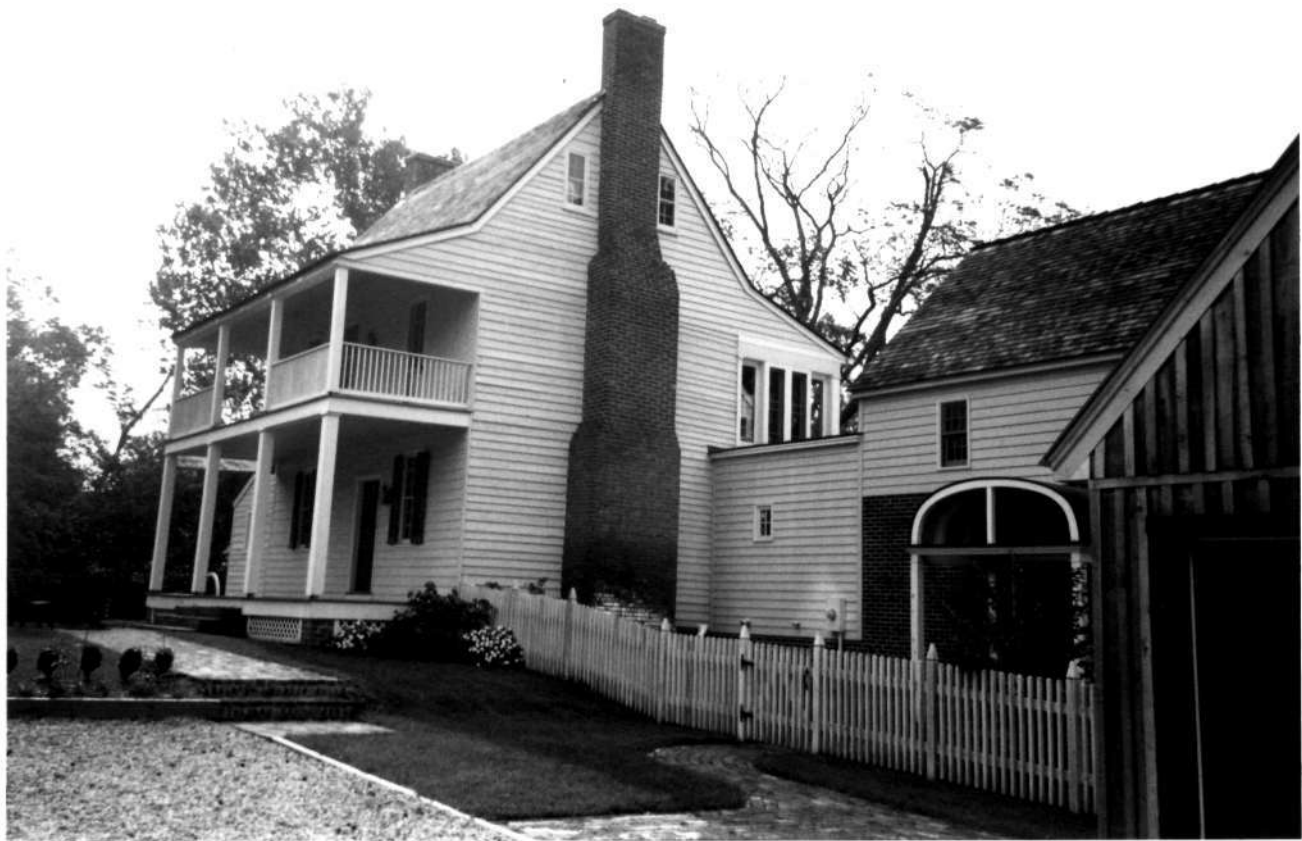
- 1 CH-78
- 2 Pleasant Hill Charles County, MD
- 3 Bryan McKay, 9/96
- 4 P.A.C Spero & Company, 40 W. Chesapeake Ave, #412 Baltimore, MD 21204
- 5 9205 Marshall Corner Road, Partial west elevation of House, Southeast view
- 6 11 of 16

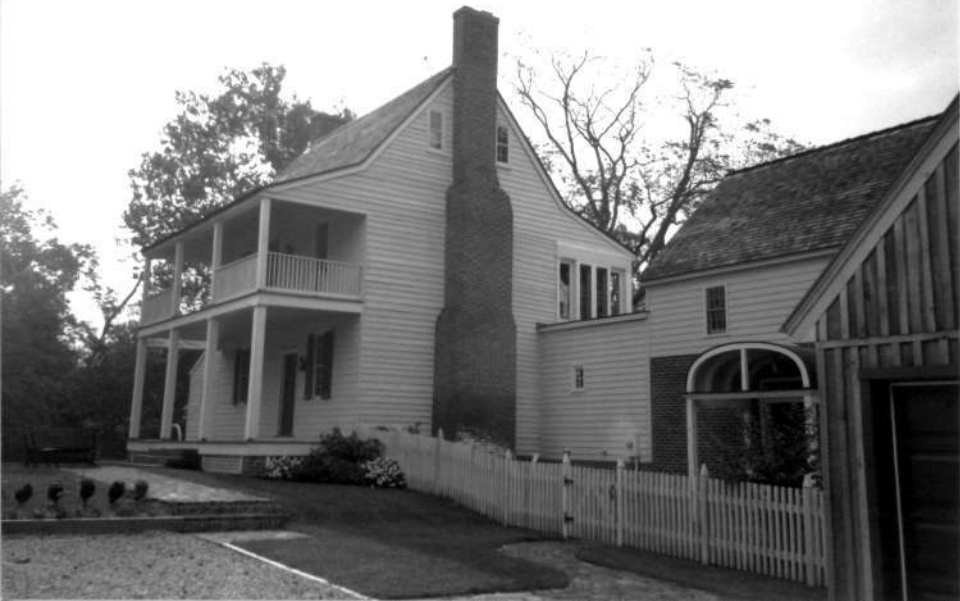
6. 12 of 16

5. 9205 Marshall Corner Road, Pental
West elevation of house, Southeast
6. View

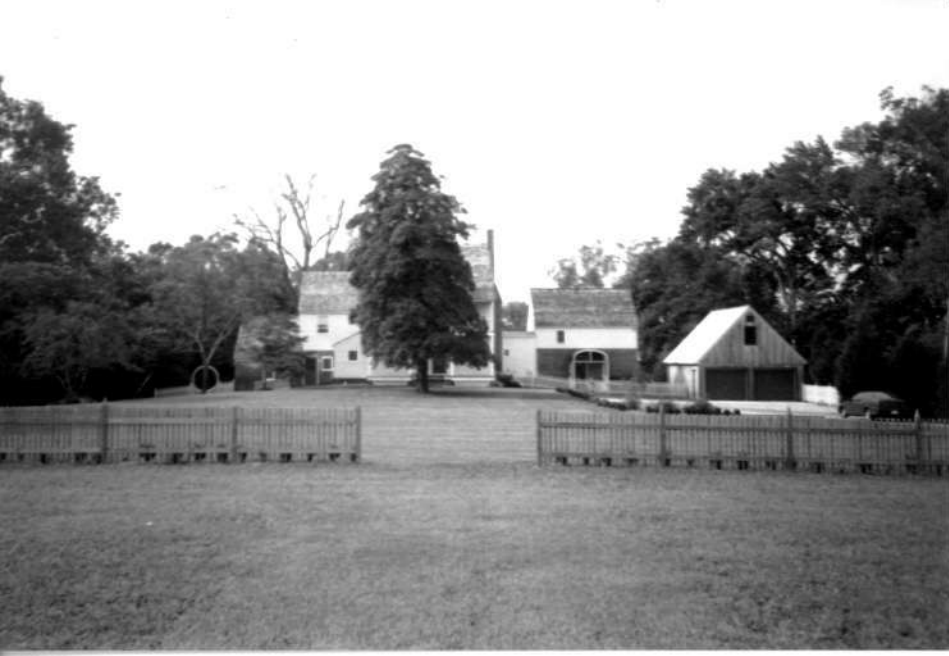
1. CH-78
 2. Pleasant Hill, Charles County, MD
 3. Ryan McBride 4/96
 4. P.A.C. Service Company, 40. W. Chesapeake Ave., Ste. 400, Baltimore MD 21211
 5. 9205 Marshall Corner Road
 6. North elevation of House South view
- 6 13 of 16

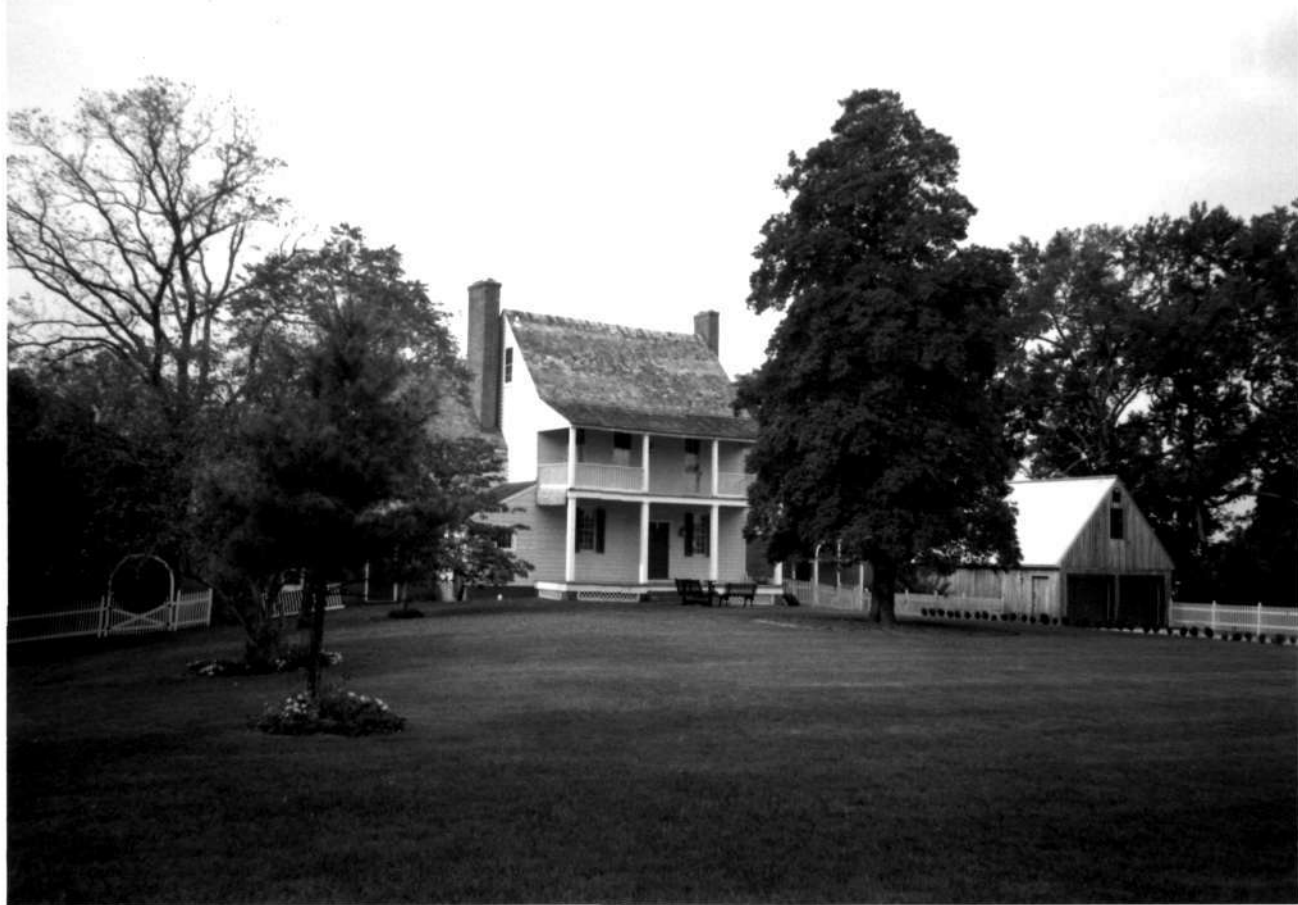
- 1 CH-78
- 2 Pleasant Hill, Charles County, MD
- 3 Bryan McKay, 9/96
- 4 P.A.C. Spero and Company, 40 West
Chesapeake Ave, #412 Baltimore, MD 21204.
- 5 9205 Marshall Corner Road
North elevation of Main House Southwest
view
- 6 14 of 16

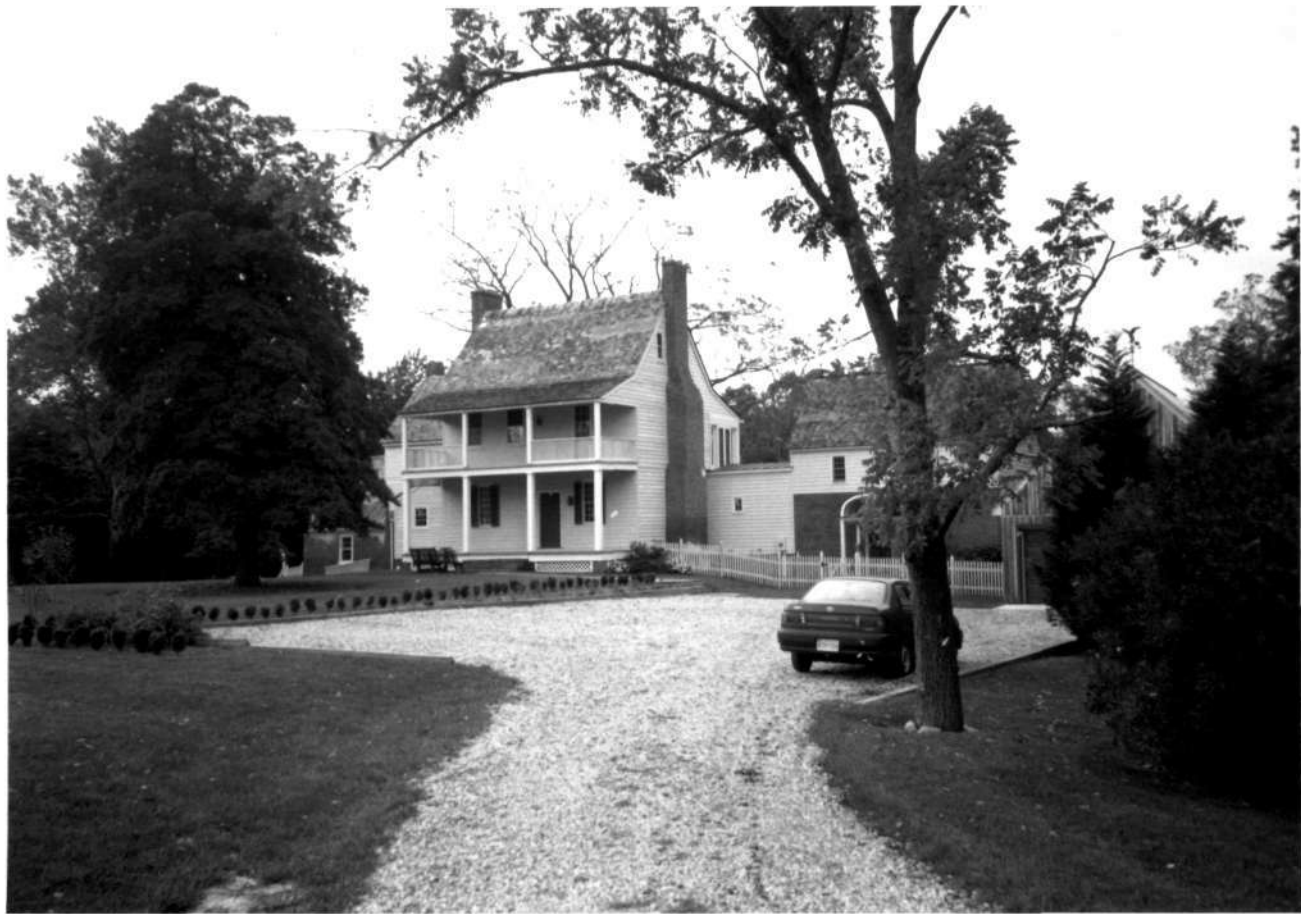
- 1 C.H.-78
- 2 Pleasant Hill, Charles County, MD
- 3 Bryan McKay, 9/96
- 4 P.A.C. Spero & Company, 40 W. Chesapeake Ave, #412 Baltimore, MD 21204
- 5 9205 Marshall Corner Road, North elevation of Main House Southeast view
- 6 15 of 16

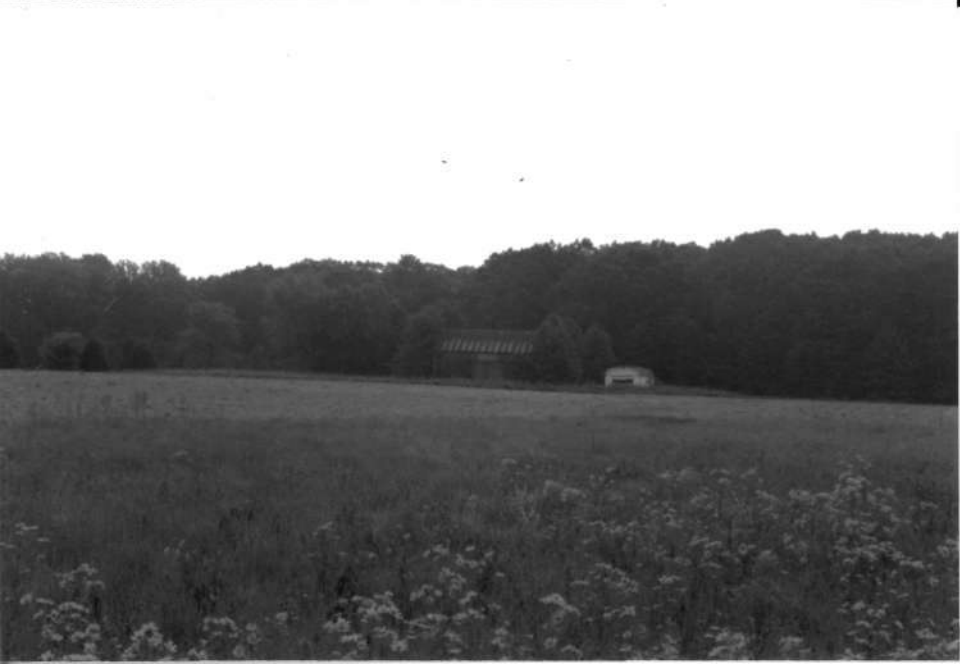
1. (unclear)
2. Pleasant Hill Charles County MD
3. Rydman & Co
4. P.A.G. Spero & Company, 401 W. Chesapeake Ave, St. 412, Baltimore Md 21204
5. 9205 Marshall Corner Road, barn and garage Southeast view
6. 16 of 16

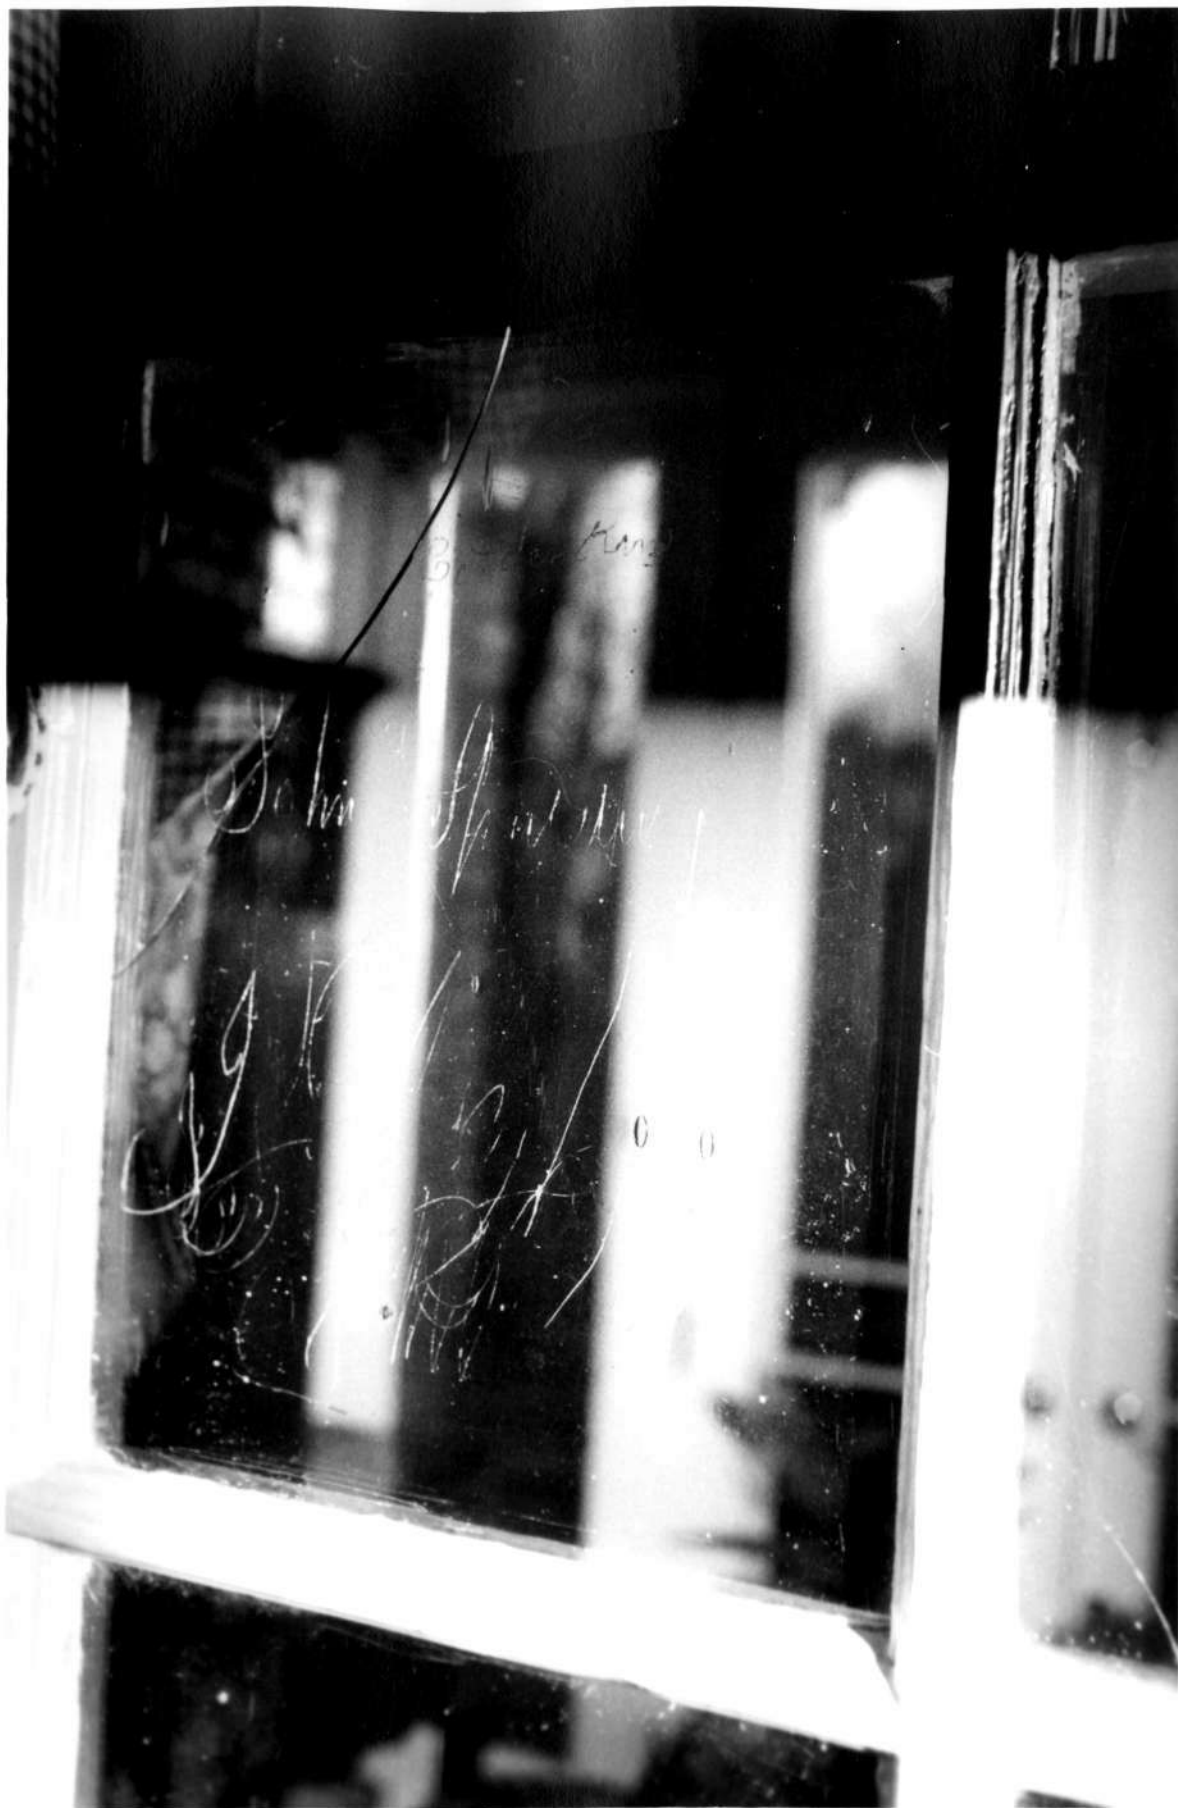
8 OF 12

INTERIOR: "JOHN SPALDING" SCRATCHED IN GLASS
SOUTH WALL OF MAIN BLOCK, VIEW FROM N
